Navion Service Letter No. 89
September 15, 2010

Subject: Suggested Nondestructive Inspection procedures for Landing Gear.

Effectivity: Serial Number NAV-4-002 and Subs.

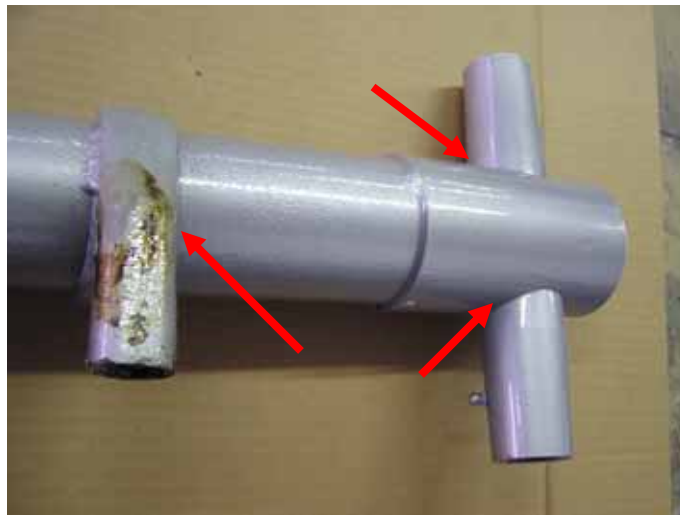
- e) Magnetic particle inspect main landing gear shock strut outer cylinder assembly part number 145-33903-1 or -101 and -2 or -102 by qualified NDI personnel. Extra attention on trunnion/ strut joint and collar and drag link attachment. (Ref fig 6, fig 7 and fig 8)

Fig. 6
Magnetic particle inspect for cracks and separation.

- f) If damage is found in specified areas reference SRM Fig. 5-2 and/or Fig. 5-3 and/or contact Sierra Hotel Aero, Inc for technical assistance.
- g) Replace all non serviceable parts with new parts per Navion Part Manual Chapter 24.

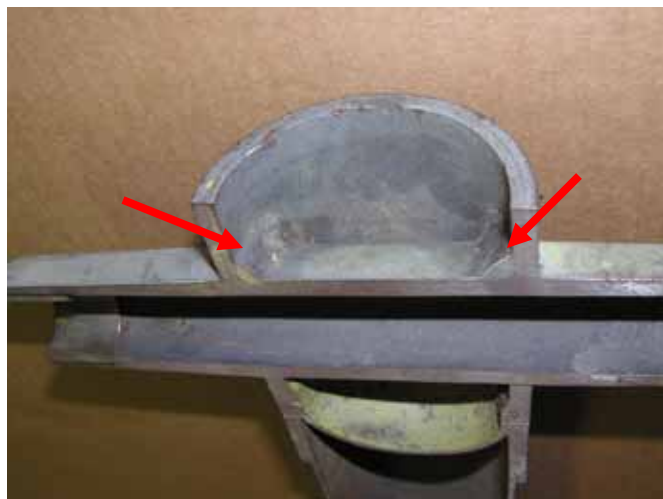
Fig. 7
Magnetic particle inspect for cracks and separation.
