FIELD SERVICE BULLETIN

FIELD SERVICE BULLETIN NO. 18
SEPTEMBER 26, 1952

SUBJECT: AILERON CONTROL CHAIN JAMMING

EFFECTIVITY: ALL NAVION AIRCRAFT

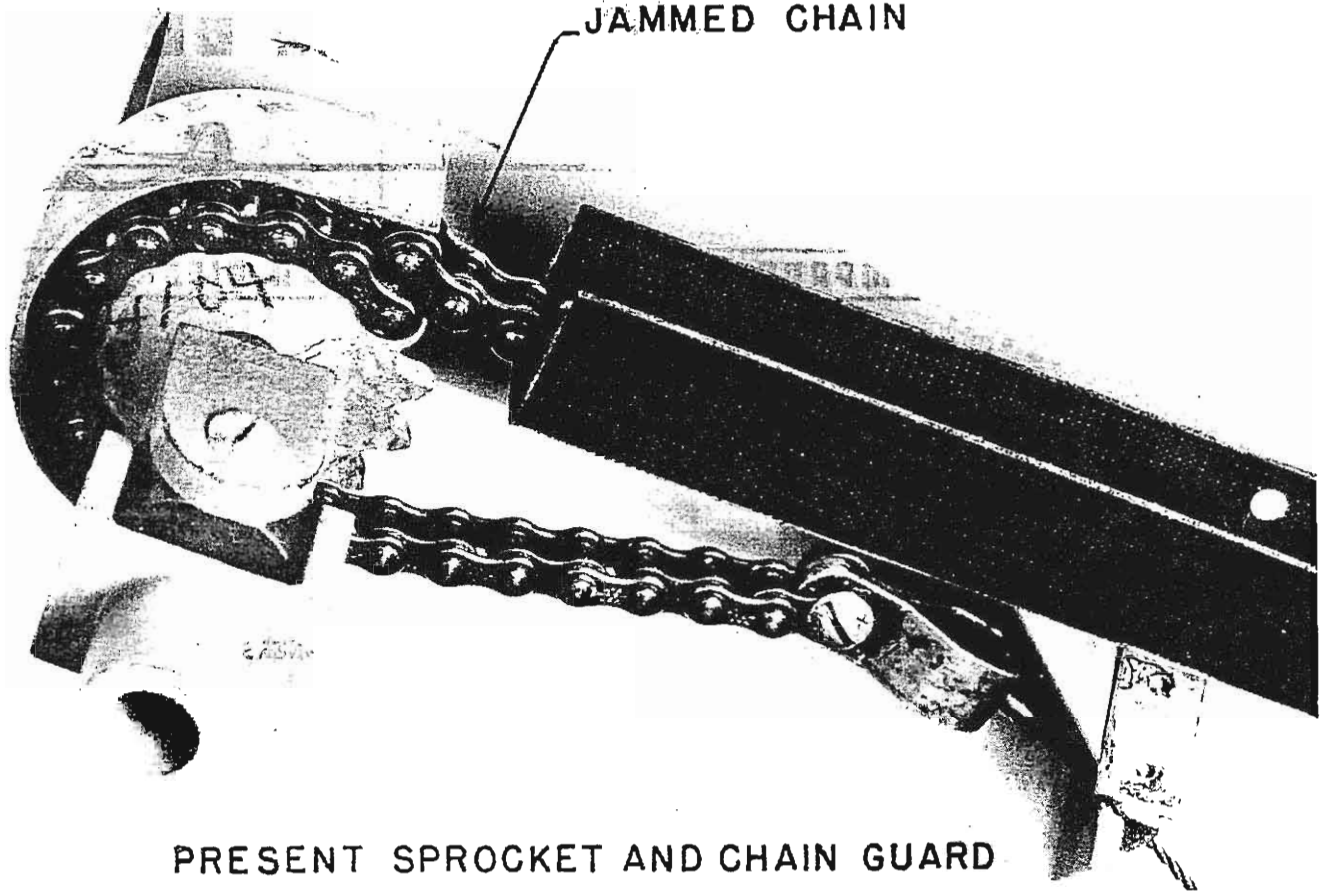
PRESENT SPROCKET AND CHAIN GUARD

An instance of aileron control jamming has been reported on a Navion airplane. The jam occurred during an instruction flight. Careful analysis of the chain installation on the control column has revealed that a jam can occur when the aileron control cables are rigged to less than the required (30 lbs.) tension and a quick reversal of forces is applied to the control wheel. It has also been determined that a jam may occur by opposite rotation of the control wheels such as might occur should the student fight the instructor's controls.

JAMMED CHAIN
