FIELD SERVICE BULLETIN

FIELD SERVICE BULLETIN NO. 23
5 DECEMBER 1955

SUBJECT: INSPECTION AND/OR REPAIR OF REAR WING SPAR JUNCTION FITTINGS

EFFECTIVITY: ALL NAVIONS

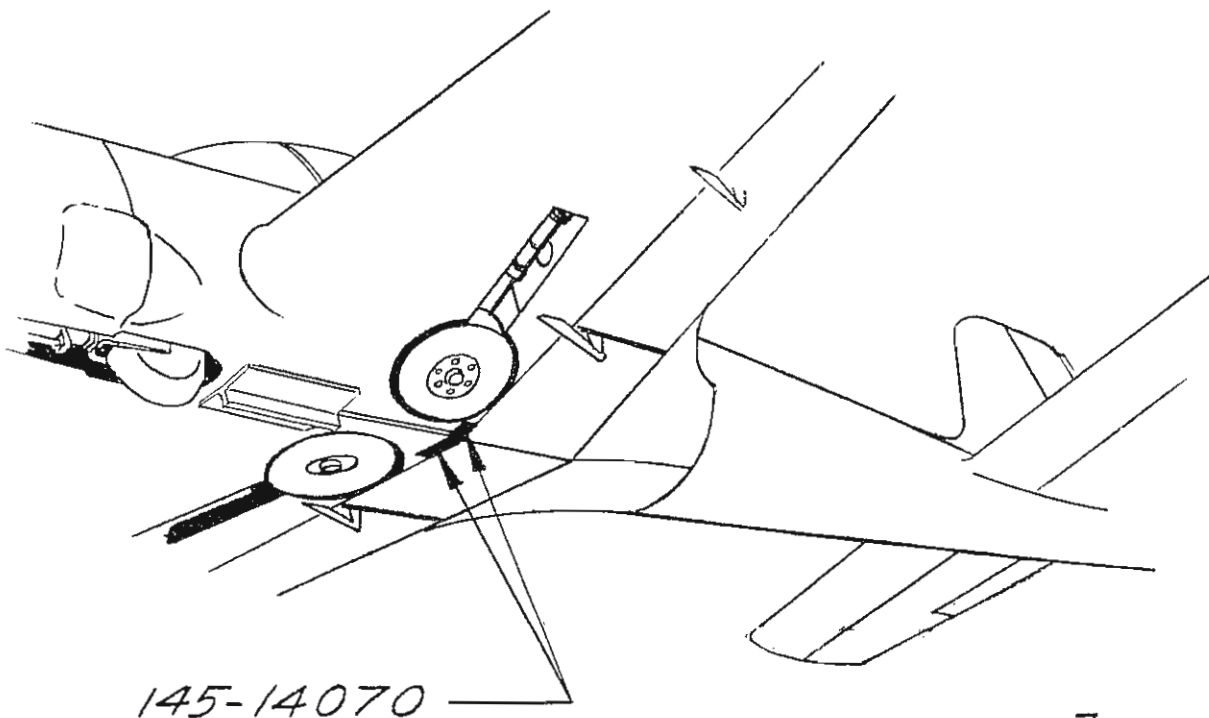
1. Inspection of some Navion aircraft has revealed that cracks may exist in the right, left, or both rear wing spar junction fittings at wing sta. 0.00. Immediate inspection of fittings 145-14070 must be made by removing the bolt connecting the right and left fittings. Access to fittings is through main wheel wells, facing aft.
2. Install back plate, shown on attached sketch, in each fitting.
3. If cracks do exist, stop-drill end of cracks with #60 (.040) drill and install back plates in each fitting.
4. No further inspection will be necessary.
5. It is understood that a C. A. A. airworthiness directive covering this subject will be issued at an early date.
