# FIELD SERVICE BULLETIN

FIELD SERVICE BULLETIN NO. 9  
SEPTEMBER 1, 1950

SUBJECT: INSPECTION OF SHAKESPEARE THROTTLE CONTROLS

EFFECTIVITY: ALL NAVIONS, FACTORY SERIAL NO'S. 1789 THROUGH  
2019; 2021 THROUGH 2026; 2028 THROUGH 2142;  
2144 THROUGH 2169; 2171 THROUGH 2177 AND 2180.

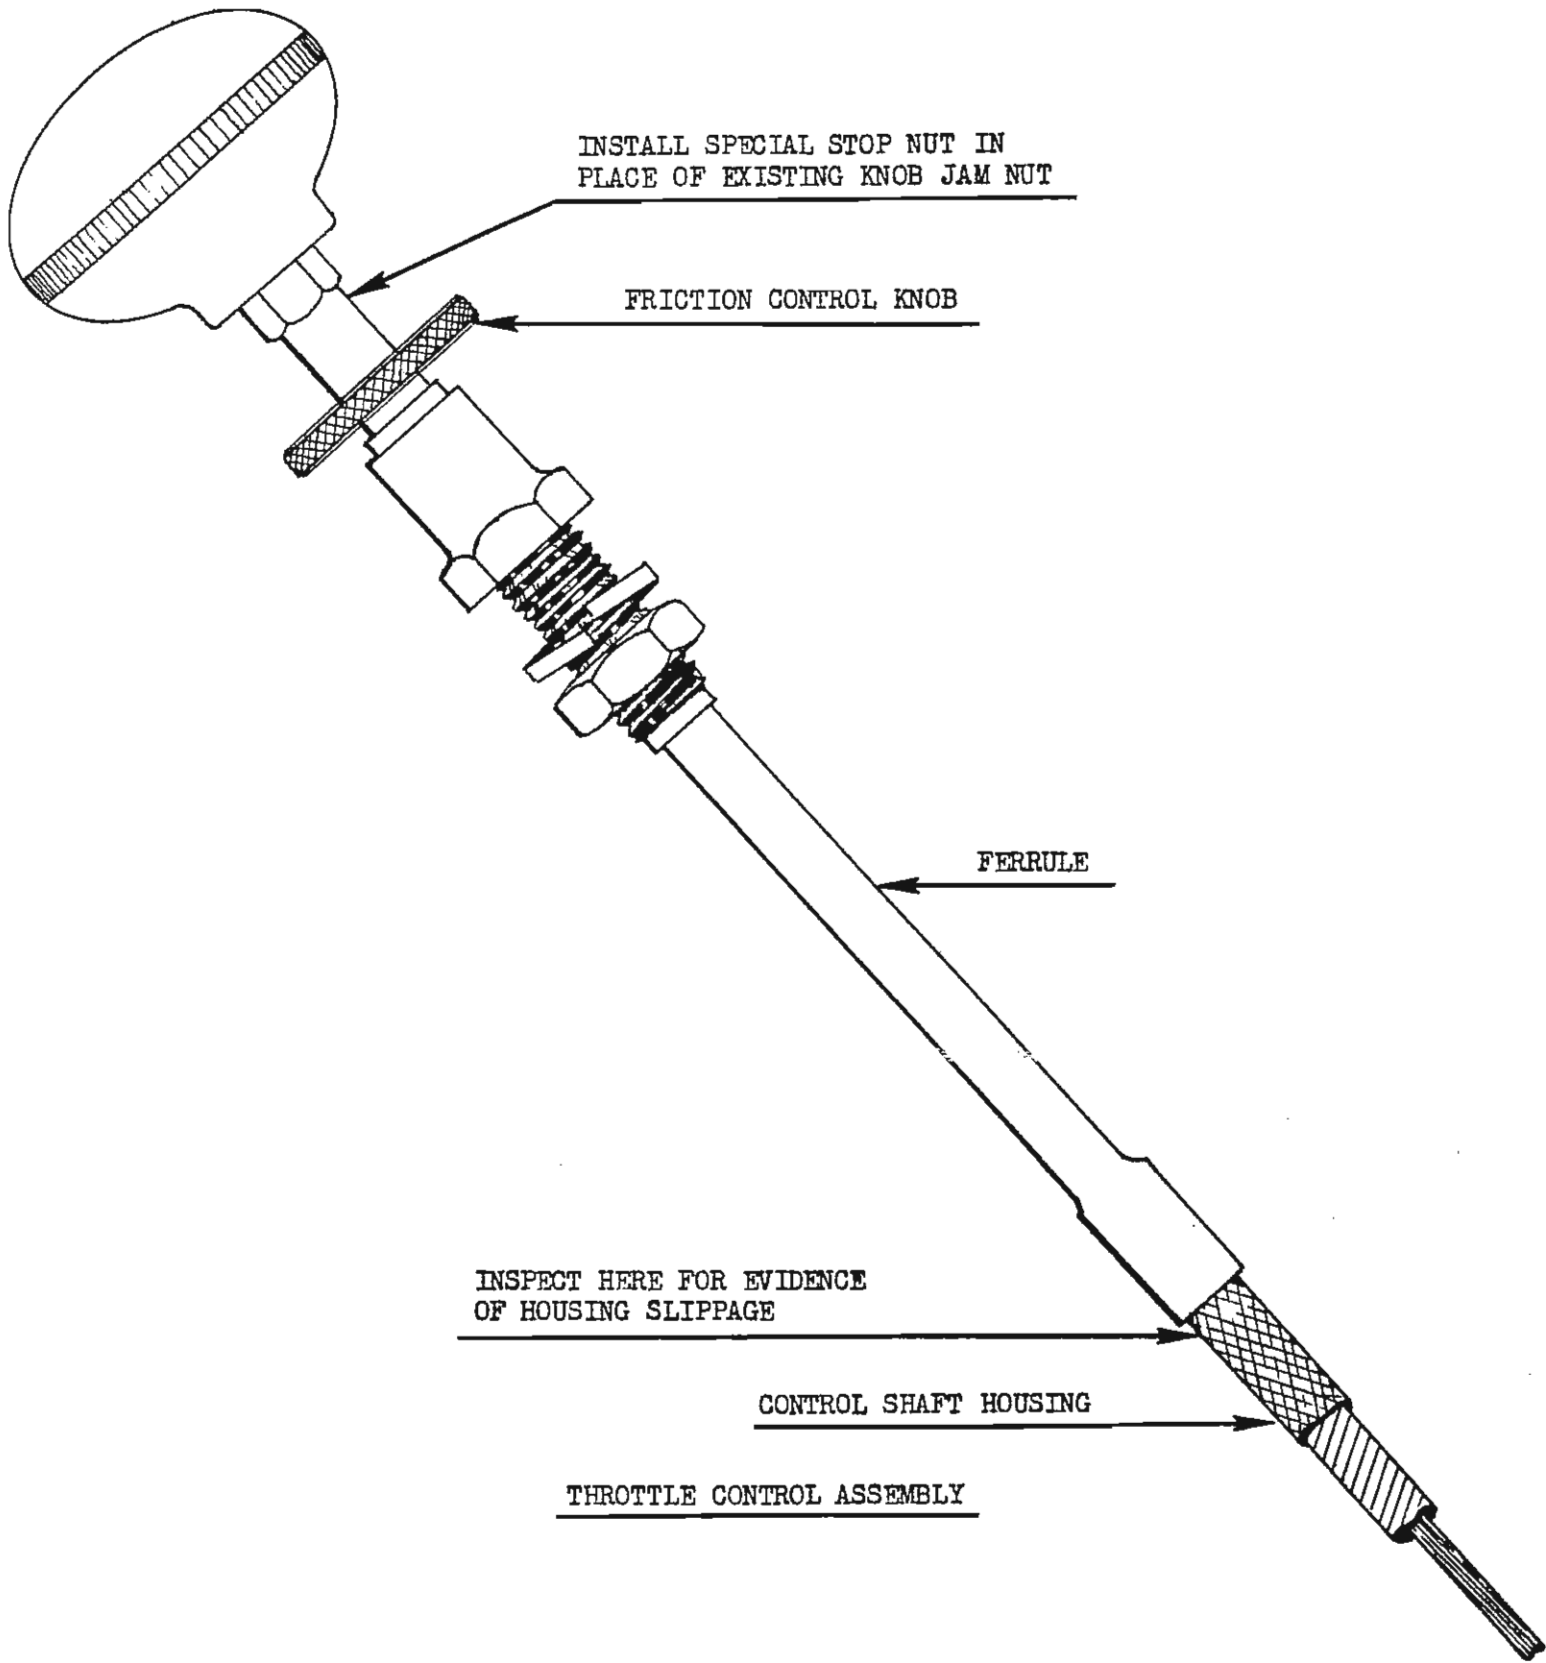
The flexible shaft housing where it enters the control ferrule, just forward of the instrument panel must be IMMEDIATELY inspected for any evidence of slippage in the ferrule. The black, plastic coated, shaft housing will show signs of wrinkling, or chafing, on any controls where slippage has occurred. See sketch. Any control, on which definite indications of control housing slippage is discovered, must be immediately replaced with a new control assembly furnished by Shakespeare through the Ryan Aeronautical Company.

1. Remove control knob and existing jam nut.
2. Disconnect throttle control from throttle lever on carburetor.
3. Push throttle control forward as far as possible and screw special stop nut on shaft until it contacts throttle friction control with friction control turned up snug, then turn nut four more complete turns.
4. Install throttle knob and reconnect control to carburetor throttle lever. Rerig throttle as necessary to provide full throttle movement with slight control cushion.
