NAVION SERVICE LETTER # 87
FEBRUARY 20, 1965

MANDATORY

SUBJECT: Fuel Accumulator Tank - Replacement
EFFECTIVITY: All Model Navions
REFERENCE: Ryan Service Letter #78
DRAWING: Tanks experienced corrosion - Item #2307 - P/N 145-48004
Replacement Tanks - Item #2307-10 P/N 145-48006

FUEL SYSTEM ACCUMULATOR TANK MAINTENANCE AND MODIFICATION

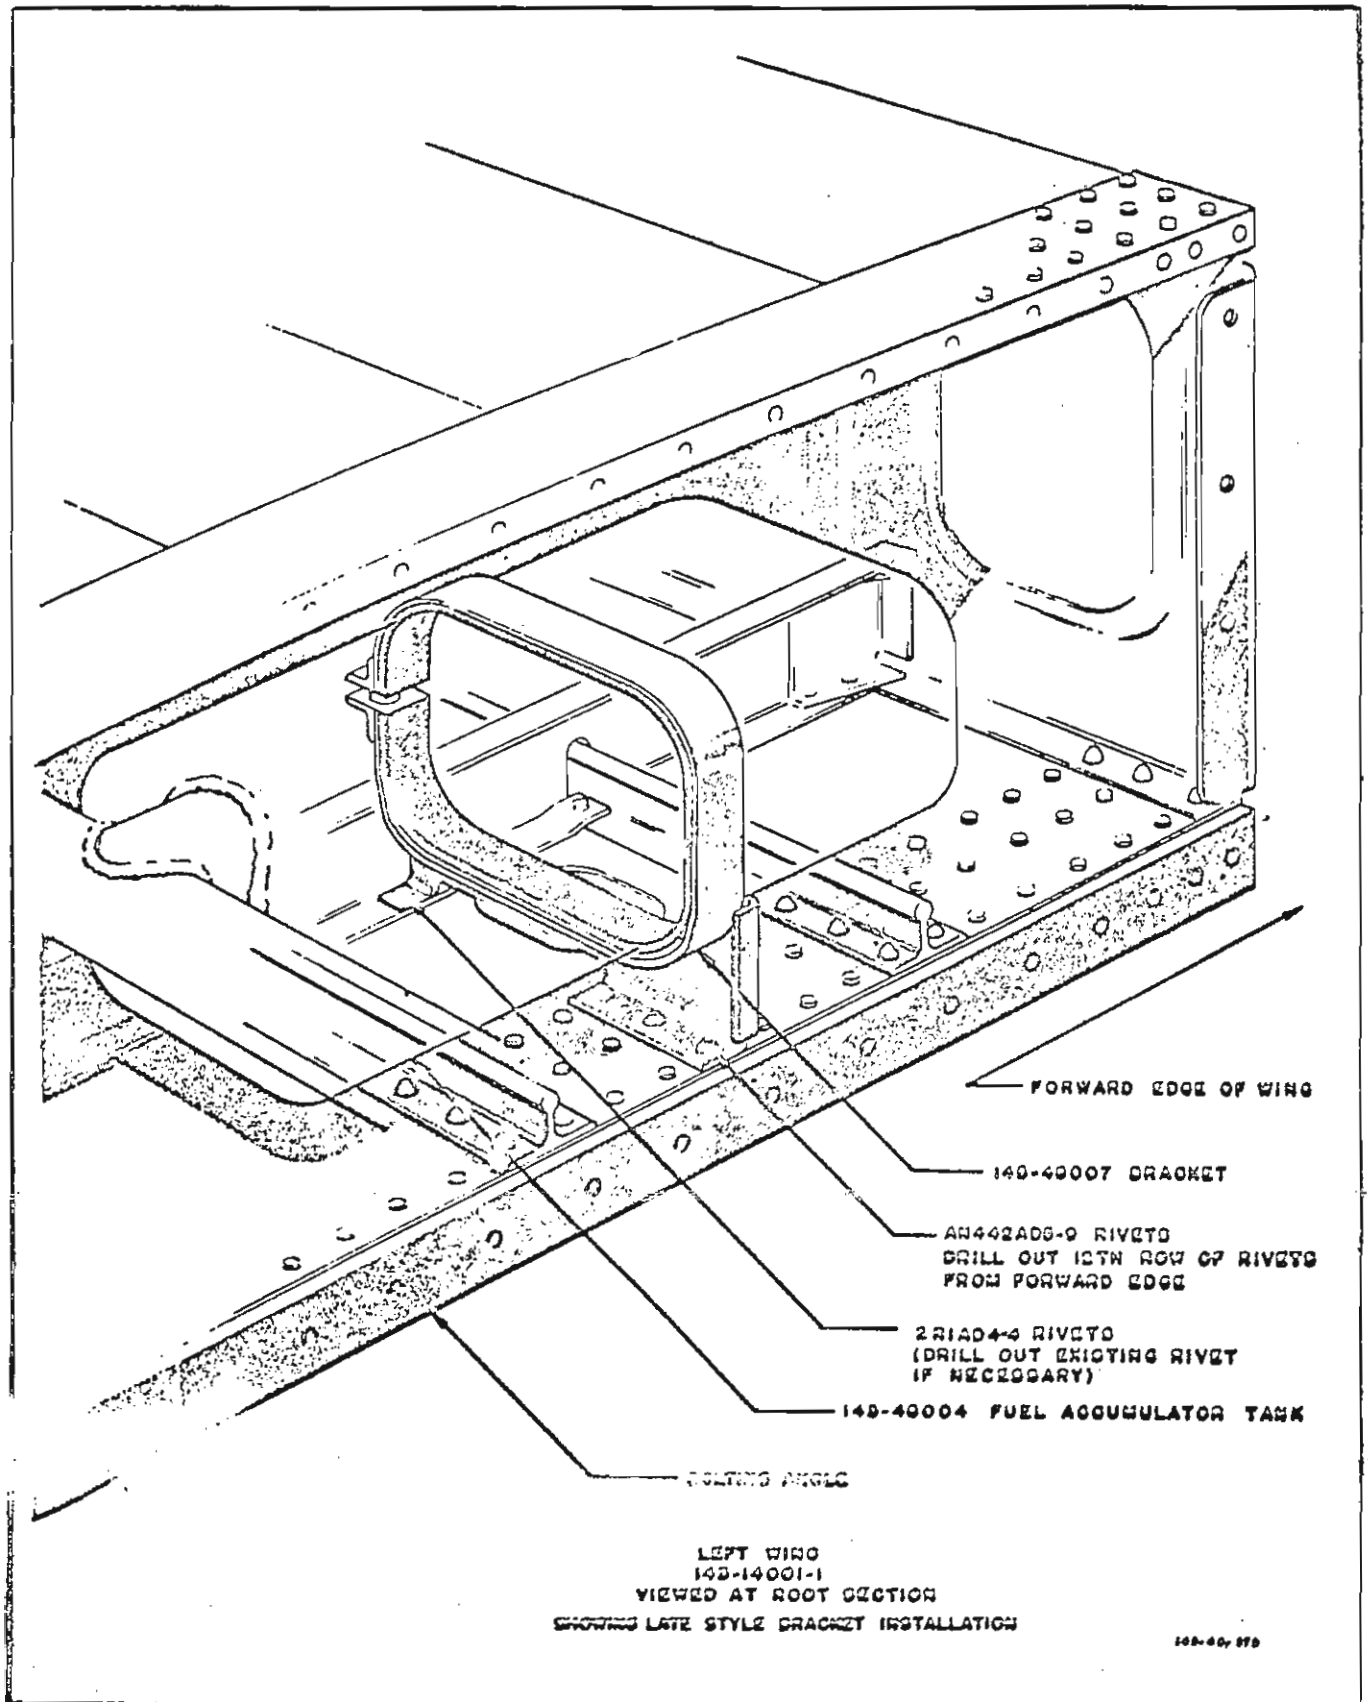
Figure 1 - Accumulator Tank Bracket

Navion airplanes prior to factory serial number NAV-4-1251 have the fuel accumulator tank supported by two 145-48008 brackets riveted to the 143-14010-20 center rib. Airplanes subsequent to NAV-4-1251 have the fuel accumulator tank supported by one 145-48007 bracket, riveted to the bolting angle of the left wing.

1. Inspect inside the root section to see if fuel accumulator tank bracket 145-48007 is installed. If the 145-48007 bracket is installed, remove it from the wing as follows:
 - a. Drill out the three AN442AD5-9 rivets which attach one end of 145-48007 bracket to the wing bolting angle. This is the 12th row of rivets aft of forward edge of the wing.
 - b. Drill out one 2R1AD4-4 rivet attaching the outboard end of the 145-48007 bracket, and remove bracket from wing.
 - c. Replace the first three removed rivets with AN442AD5-9 rivets. Replace the removed outboard rivet with one 2R1AD4-3 rivet.

1. Inspect the inside root section of left wing to see if the 145-48007 fuel accumulator tank bracket is installed. If bracket is not present, install the new 145-48007 bracket, received as a loose part, as follows:
 - a. Drill out three AN442AD5-8 rivets which run spanwise in the bolting angle. This is the 12th row of rivets aft of the forward edge of wing.
 - b. Clamp 145-48007 bracket in the wing with the flange of bracket over holes just drilled. Drill through bolting angle holes and bracket flange with a No. 21 (.159) drill.

CAUTION: Do not elongate holes in bolting angle.

- c. Attach bracket to bolt angle with three AN442AD5-9 rivets.
- d. Drill through rib, wing skin, and pilot hole on outboard flange of bracket with No. 30 (.128) drill, and install one 2R1AD4-4 rivet.
