# FIELD SERVICE BULLETIN

FIELD SERVICE BULLETIN NO. 16

SUBJECT: CARBURETOR AIR DUCT CHANGE

EFFECTIVITY: ALL SUPER 260 MODEL NAVIONS

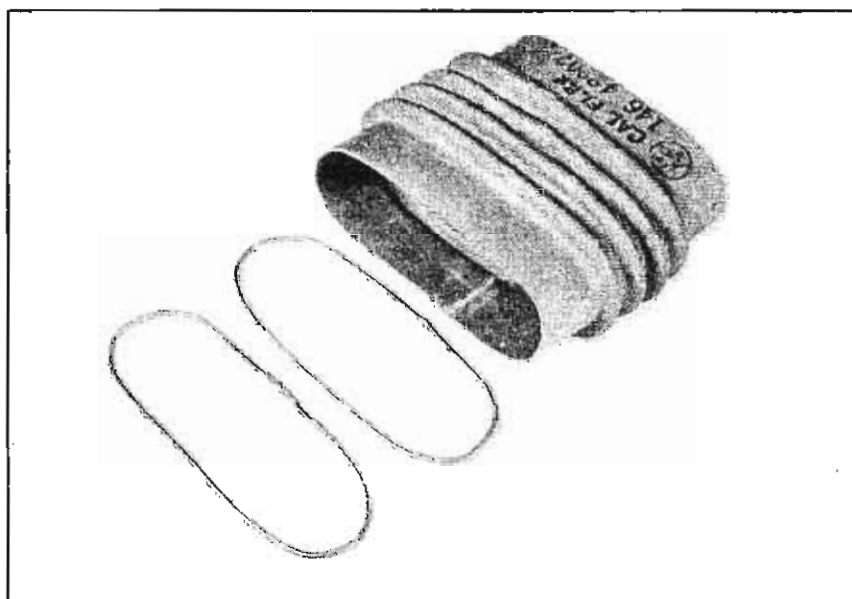
Additional service experience since the issuance of Field Service Bulletin No. 15 has revealed that under certain conditions it is possible for the 146-42207 flexible air duct between the carburetor air filter assembly and carburetor air mix box to collapse causing partial stoppage of the carburetor air induction system with some loss in available engine horsepower. To preclude any possibility of this happening it is mandatory that a wire reinforced duct be used.

A simple method of reinforcement consists of two hoops made of 1/8" diameter welding rod, as shown in the illustration below. These hoops to be installed in the two center bellows of the duct. The hoops should be of such a size and contour that they fit tightly in the duct so there is no possibility of their coming out during flight.
