FIELD SERVICE BULLETIN

FIELD SERVICE BULLETIN NO. 21
5 August 1954

SUBJECT: RELATIVE MOTION BETWEEN FUSELAGE AND WINGS

EFFECTIVITY: ALL NAVION AIRCRAFT (MANDATORY)

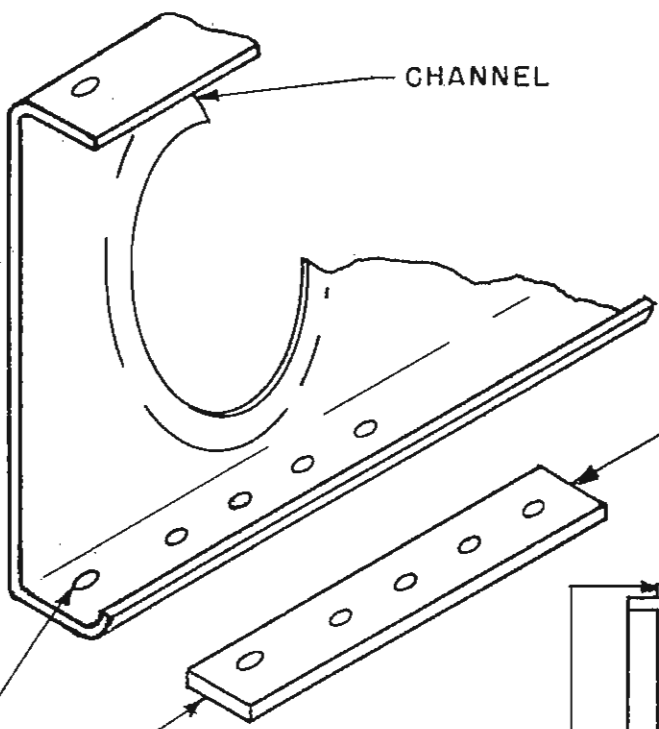
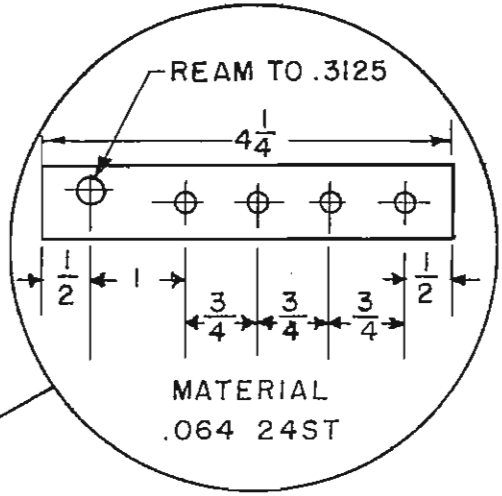
AFT WING ATTACHMENT FIG. 1

- c. Remove wing fillets for access to two aft wing attachment bolts.
 - d. Station one man at outboard leading edge of wing to shake the wing as previously described while another man is observing the six bolts attaching wing to fuselage to determine any looseness due to elongated holes in structure.

- e. Where elongated holes are evident proceed as follows.
- f. Ream holes of the four forward wing attachments to receive the next larger size bolts. Remove and replace ONLY one bolt at a time and torque to 140 inch pounds (see Figure 2).
- g. Remove the two AN5-65A aft attachment bolts, spacers, washers, tubes and nuts.
- h. Drill and attach the two .064-24ST alclad strips (see Figure 1), one on each end of the bottom inside flange of frame 142.57 and rivet each strip with four 5/32 inch rivets.
- i. Shorten the two tube spacers to fit within the channel.
- j. Install two AN5-65A bolts with nuts, washers, spacers and tubes. Torque to 140 inch pounds.
- k. Drill top wing skin at fifteen places parallel to longeron on each side of cockpit, and blind rivet the right and left .064-24ST alclad angle in place (see Figures 3, 4, 5 and 6).
