FIELD SERVICE BULLETIN

Navion

NO. 30
MAY 5, 1947

SUBJECT: HARTZELL PROPELLER PISTON GUIDE PIN SAFETYING.

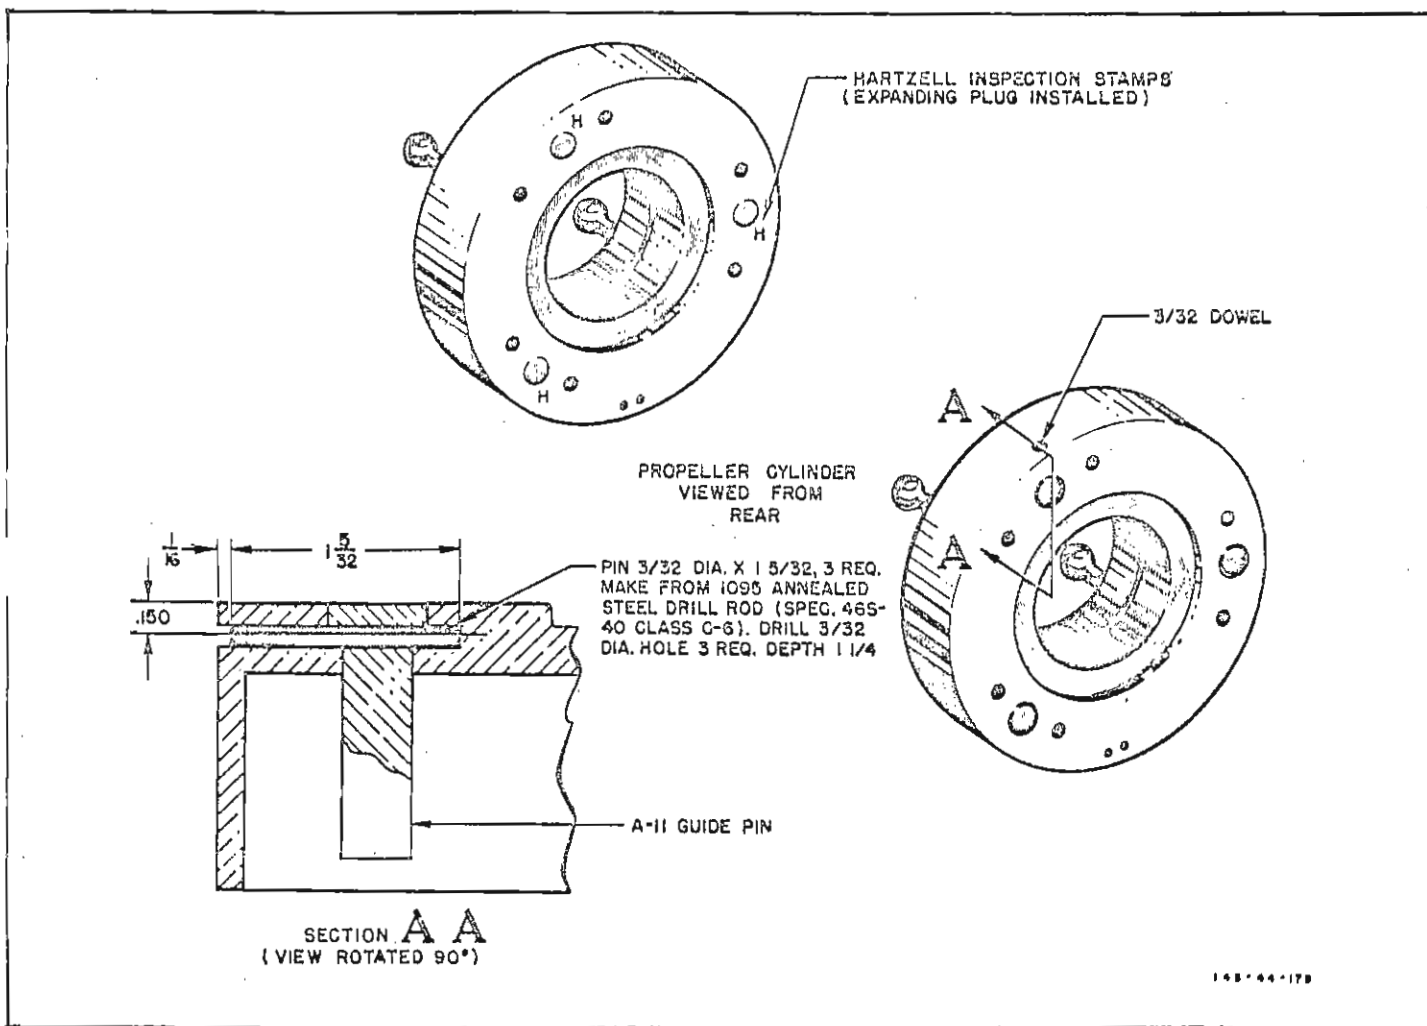
Figure 1. Propeller Piston Guide Pin Staking

The propeller piston guide pins require additional safetying in order to prevent loosening and subsequent loss of engine oil. This is accomplished by the installation of a steel dowel through the guide pin. Future production propellers will have a shorter guide pin retained with an expanding plug.

1. Inspect the rear circumference of the control cylinder directly above the left hand guide pin for presence of a 3/32 inch taking pin.

2. Inspect the rear face of the control cylinder for a letter H stamped near each guide pin head, which signifies an expanding plug is installed.

1. Remove propeller and engine nose cowl.
2. Disconnect lines to servo valve and remove propeller piston and cylinder assembly from engine.
3. Lay out and drill the cylinder as shown in Figure 1.

NOTE: Caution should be used in drilling the cylinder so that the guide pin will be drilled on its diameter. Protect inside and front of cylinder and piston assembly from drill cuttings by covering with clean rags. Piston and cylinders are matched assemblies.

4. Insert steel staking pins, so that the head of the pins lie 1/16 inch below surface of cylinder.
5. Punch stake edge of hole.
6. Re-install cylinder unit, propeller and nose cowl on airplane.
7. Notice of compliance with this bulletin must be entered in the airplane log book.
