# FIELD SERVICE BULLETIN

# Navion

BULLETIN NO. 33  
JULY 2, 1947

SUBJECT: ELEVATOR LEADING EDGE RIB INSTALLATION

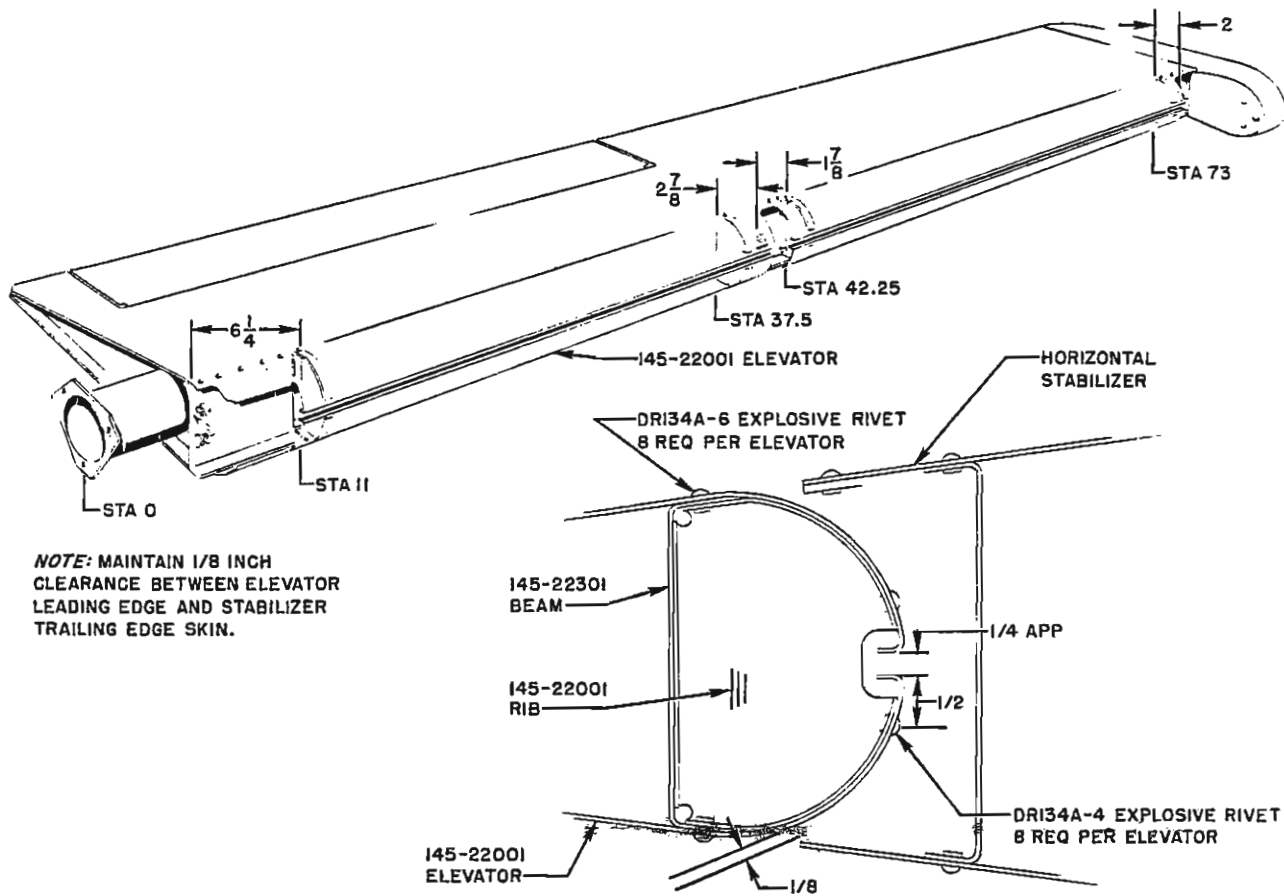
It has been noted in a few cases that the elevator leading edge fairing has developed longitudinal cracks. All elevators will be modified by incorporation of leading edge ribs. Elevators which have skin cracks will be replaced with modified elevators.

The elevators should immediately be inspected and if not cracked, should have rework accomplished at earliest possible date. The cracks usually first appear in the lower left hand elevator skin at the hinge cut-outs. Inspect top and bottom skins of both elevators forward of and parallel to the line of rivets which attach the skin to the front beam.

7. Lay out the elevator leading edge for rib installation using following dimensions. See Figure 1.

(a) 145-22001-34 rib located  $6 \frac{1}{4}$  inches from inboard end of elevator skin.

(b) 145-22001-35 rib located  $2 \frac{7}{8}$  inches inboard from center hinge bracket.

(c) 145-22001-36 rib located  $1 \frac{7}{8}$  inches outboard from center hinge bracket.

(d) 145-22001-37 rib located 2 inches inboard of outboard hinge bracket.

NOTE: Ribs have consecutive dash numbers and must be installed at specified stations. All rib flanges face the hinge cutouts. Elevator skin must follow contour of rib when drilling and riveting, to maintain approximately  $1/4$  inch gap at forward edge.

NOTE: The  $1/8$  inch clearance between the stabilizer trailing edge and elevator leading edge must be maintained. If rib rivets hit the horizontal stabilizer trailing edge rub strip, when elevators are operated, file a small groove in rub strip to clear the rivet head.

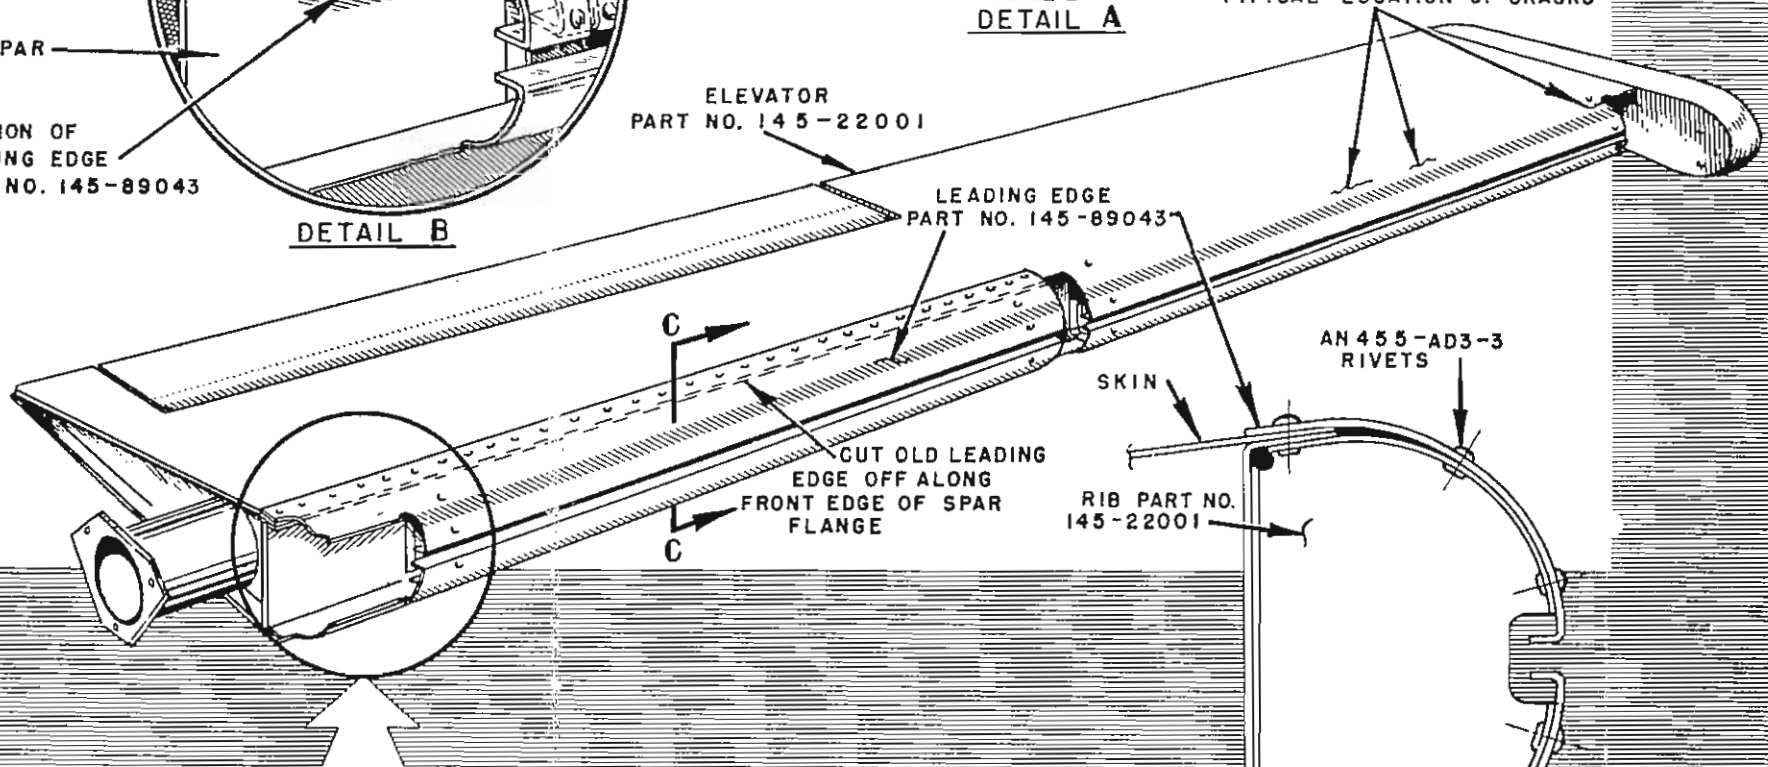
ELEVATOR LEADING EDGE REPAIR  
FIGURE 1

TYPICAL LOCATION OF CRACKS

IF CRACK IS LESS THAN  $\frac{5}{8}$  IN LENGTH AND/OR DOES NOT EXTEND BEYOND THE LEADING EDGE OF THE SPAR FLANGE, TRIM OUT AS SHOWN IN DOTTED LINE, OTHERWISE MAKE REPAIR AS SHOWN IN DETAIL B.
