FIELD SERVICE BULLETIN

Navion

FIELD SERVICE BULLETIN NO. 4
REVISED AUGUST 5, 1949

SUBJECT: INSPECTION OF NOSE GEAR RETRACTING DRAG LINK

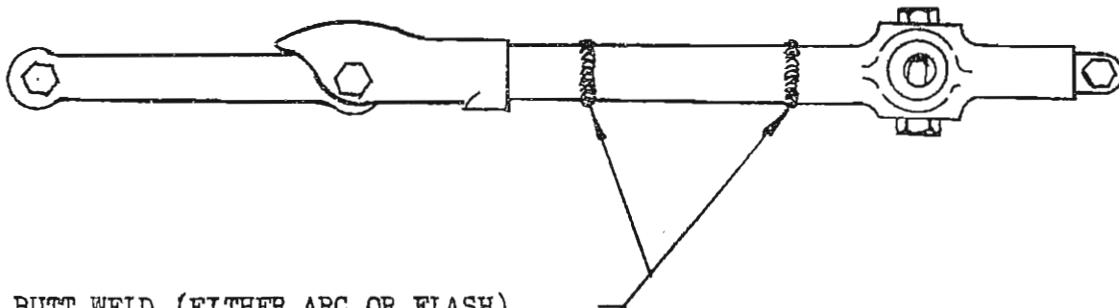
FIGURE I

A few cases have been reported on earlier Navions where Nose Gear Retracting Drag Links, Part No. 145-34106 have failed in service. Despite the fact that a large number of these links have given many hours of service without trouble, it is considered necessary to reinforce all links having butt welds (either arc or flash) regardless of the position of the oil drain hole. Reinforced links will be furnished on an exchange basis by the Ryan Aeronautical Company and handled through authorized Ryan Navion Distributors or Dealers. Owners should contact their nearest Distributor or Dealer in advance to arrange for installation and make sure that reinforced links are available.

BUTT WELD (EITHER ARC OR FLASH)
IS UNSATISFACTORY AND BULLETIN
NO. 4 WILL APPLY

EITHER TYPE OF REINFORCEMENT IS
SATISFACTORY, BULLETIN NO. 4
WILL NOT APPLY

BOLT MUST ALLOW ABSOLUTE FREEDOM
OF KNUCKLE MOVEMENT

SHOULDER SHOULD TOUCH WHEN
IN PAST-CENTER POSITION

The procedure will be to make available through authorized Ryan Navion Distributors a quantity of factory reinforced link assemblies at a cost of \$58.40. This will be a complete link assembly including Parts No. 145-34106 reinforced aft link attached to a 145-34164 forward link together with 145-34121 hinge clevis bolt, 145-34132 bushing, 145-34183 roller, AN960 washer and AN980-T nut. (See Figure 1.) Installation will be made for Navion owners on an exchange basis whereby parts removed from airplanes will be returned to the factory prepaid for a credit of \$50.40 for a complete assembly. This credit can only be allowed if parts are repairable. It is no longer necessary to submit an Application for Warranty Adjustment to obtain credit. All parts returned MUST be properly identified by tags. Distributor or Dealer installation cost, to be borne by the airplane owner, should not exceed the approximate equivalent of two man hours. When returned parts are received at the factory they will be inspected and credit will be issued for all repairable parts. Link assemblies will be properly mated and the correct over-travel angle provided; therefore, exchange assemblies must be complete as shown in Figure 1. In the event an incomplete assembly is returned, missing part or parts will be added and customer charged for the additions.

Install replacement links consisting of the following Part No. 145-34120 link assembly (less Part No. 145-34108 shaft) as follows:

1. Place airplane on jacks so landing gear can be operated.
2. Remove right hand engine cooling gill cover. Place a piece of dural or wood next to skin under lower nose gear bungee attachment. This is to prevent bungee from rotating too far and damaging indicating light switches.
3. Remove bolt attaching forward 145-34164 link from nose gear strut. Remove bolt connecting operating hydraulic cylinder to 145-34106 link. Remove bolt attaching 145-34106 link to bungee shaft.
4. Install reinforced link assembly by attaching link to bungee shaft with bolt previously removed. Install bolt, attaching link 145-34164 to nose gear strut. Connect hydraulic operating cylinder strut to link and safety.
5. Operate gear with hand pump at least three (3) operations, checking indicating lights and up-locks for proper functioning.
