Date: November 19, 2013

Navion Service Bulletin No. 108R1

Subject: Cabin Air Valve Housing Support:

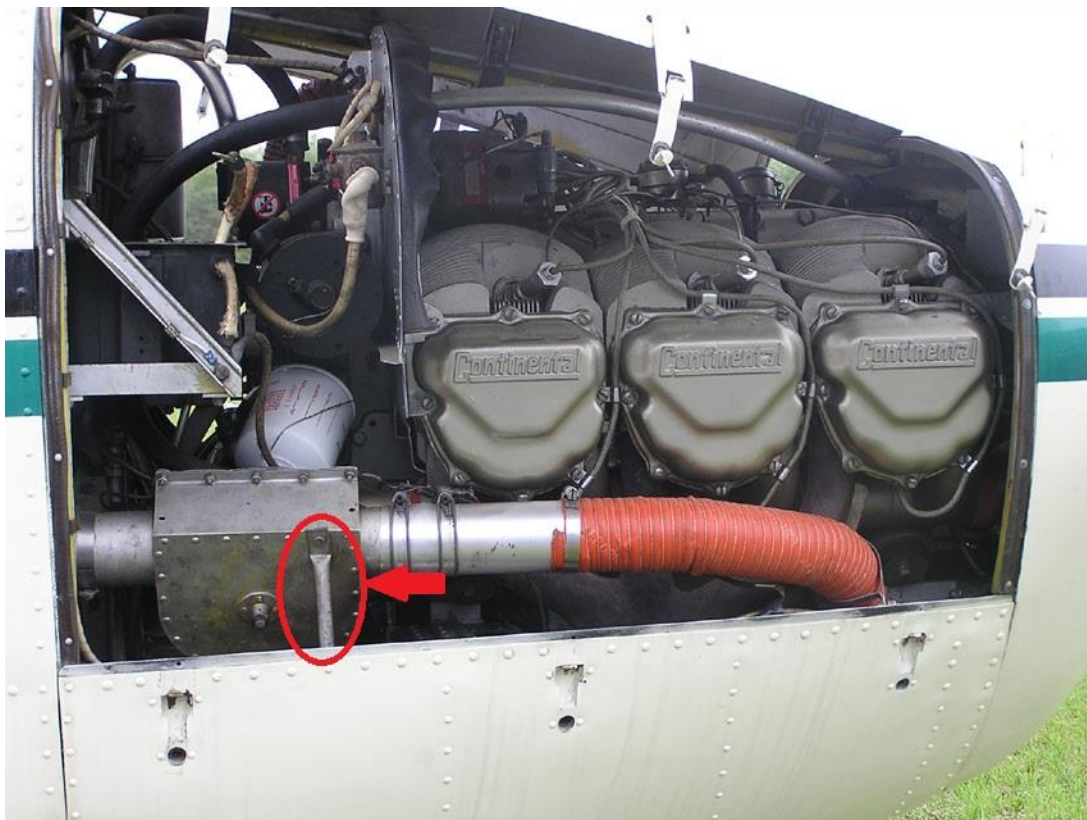
Figure 1. 147-30001/161-30001 Cowling Installation (No power plug installed). Red circle indicates support bracket (Part No.147-30001-149)

Action: Before further flight, open right side cowling and verify the installation of support bracket (Part No.147-30001-149). Reference Figure (1), Figure (2), Figure (3) and Figure (4) on subsequent pages. Install support bracket if support bracket is missing. If ground power plug is installed, check clearance between heater box and terminals. If rubber boots on terminal are missing or damaged, replace Part No.MS25171 or equivalent. Please contact SHA technical support for assistance on obtaining these parts.

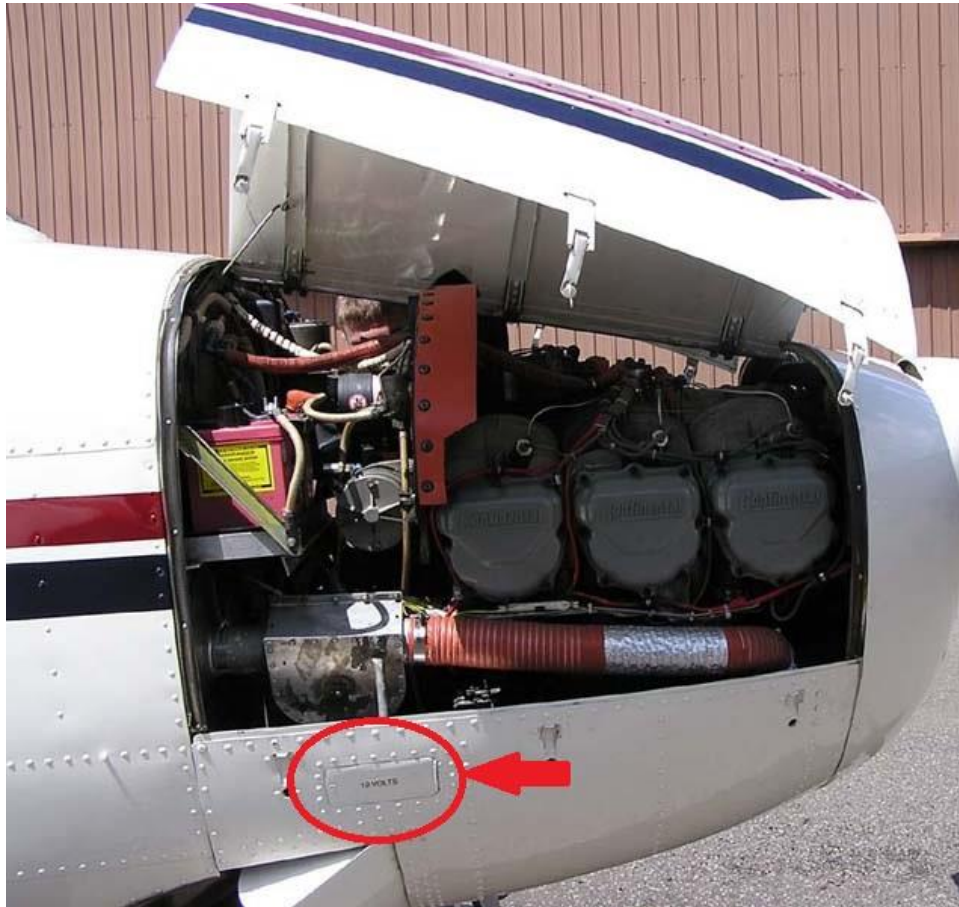
External power positive cable bent upwards at terminal stud partially exposing cable from under protective terminal boot at swaged terminal end. Cabin air valve housing PN 145-42122 SA11 contacted exposed area creating a direct short through the cabin air control cable connected to the right side lower instrument panel. Control cable subsequently heated up the lubricants inside the cable and a small 1-2 sq.in section of the right interior panel creating smoke in the cabin. Pilot shutoff master switch, cleared the smoke and landed uneventfully.

Figure 2. 147-30001/161-30001 Cowling Installation (with power plug installed). Red circle indicates power plug opening

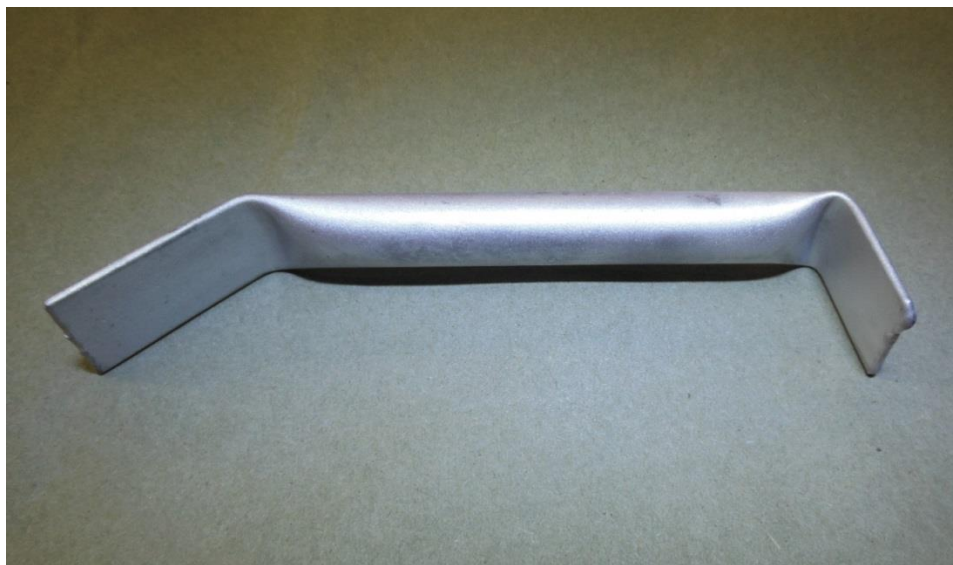
Figure 3. Support bracket (Part No.147-30001-149)

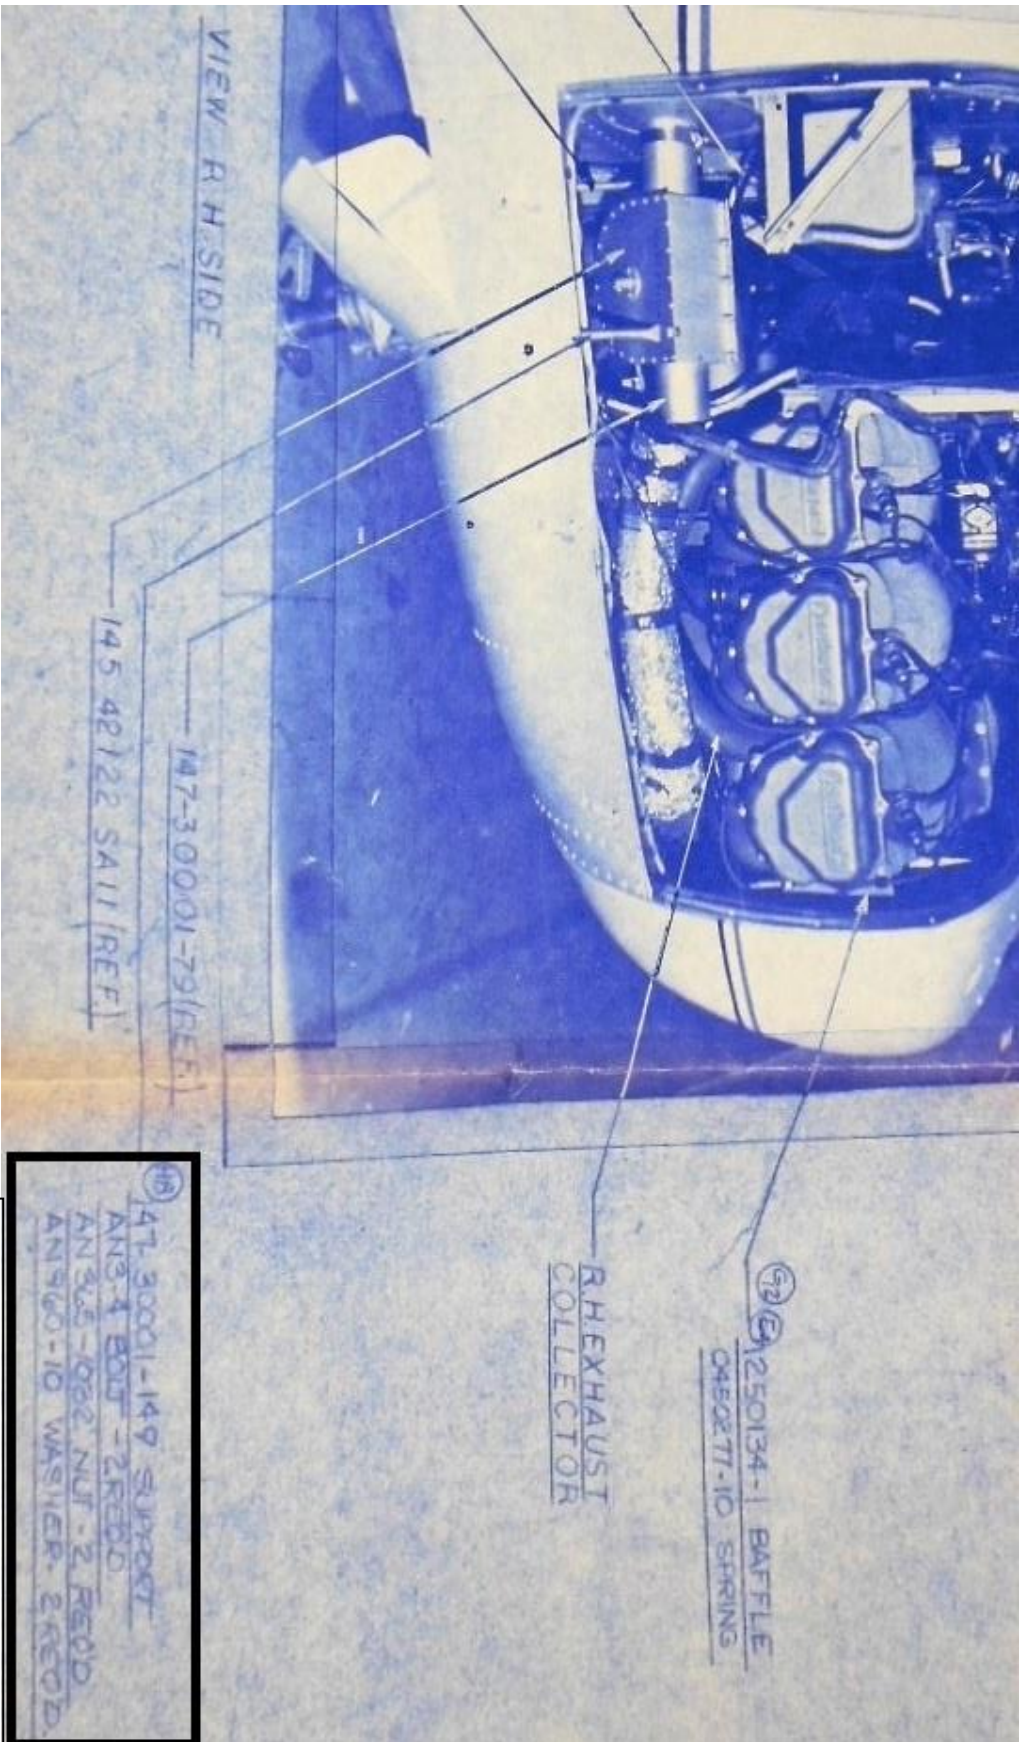
Figure 4. Original Drawing Section

Text in black box reads:
 147-30001-149 SUPPORT
 AN3-4 BOLT - 2 REQ'D
 AN365-1032 NUT - 2 REQ'D
 AN960-10 WASHER - 2 REQ'D
