Navion Service Letter No. 89
September 15, 2010

Subject: Suggested Nondestructive Inspection procedures for Landing Gear.

Effectivity: Serial Number NAV-4-002 and Subs.

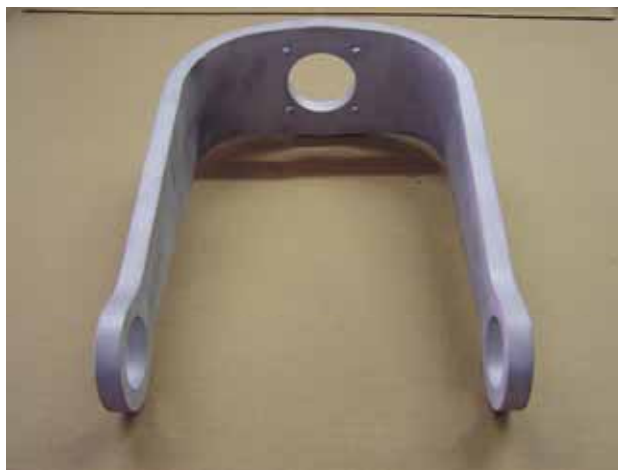
Fig.1
Nose Fork

- c) Visually inspect all nose gear parts for wear, corrosion and cracks.
- d) Florescent penetrant inspect nose gear fork part number 145-34117 and Shock strut collar part number 145-34143 or -3 by qualified NDI personnel. Extra attention on bend radius, bolt pattern and around axle attachment. (Ref. fig 1, fig 2, fig 3 and fig 4.)

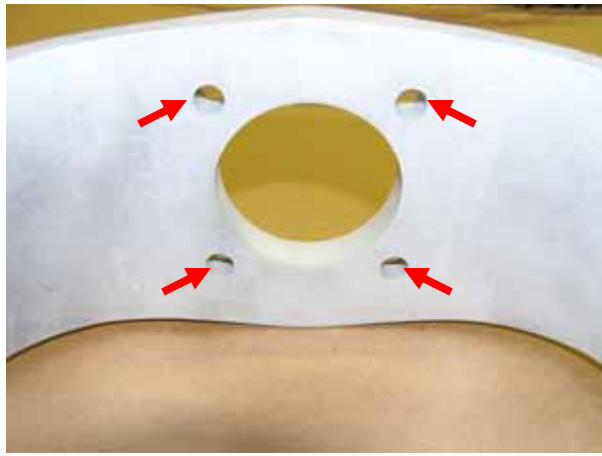
Fig.2

Closely inspect Nose fork for cracks using florescent penetrant.

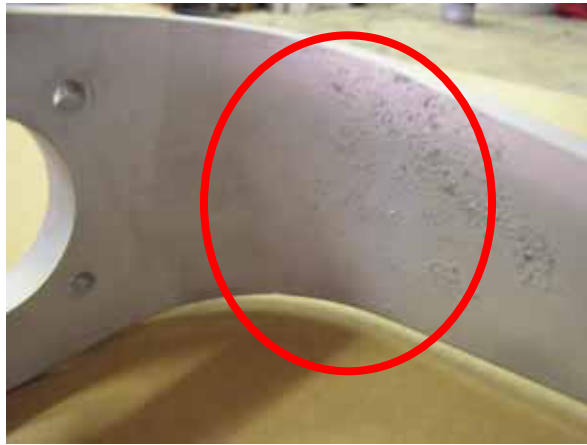
Fig.3

Perform detailed visual inspection on entire Nose fork for corrosion i.e. exfoliation corrosion.

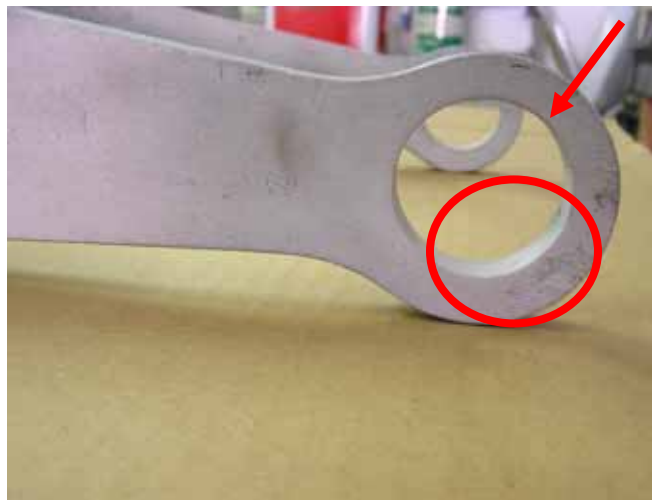
Fig. 4

Inspect for cracks with florescent penetrant and visually inspect for corrosion.

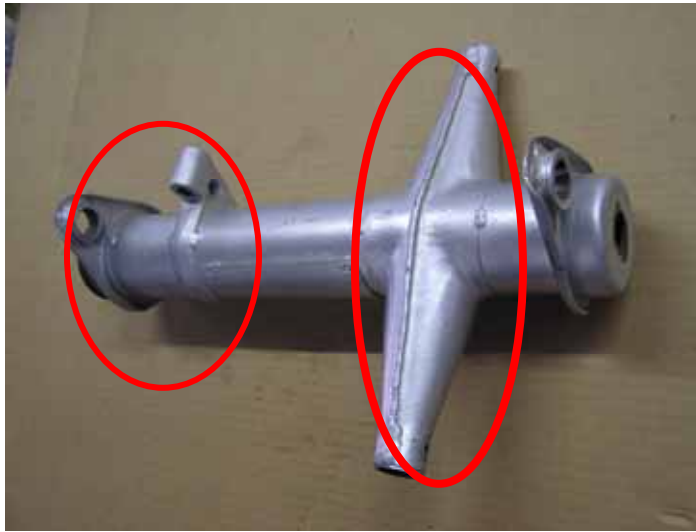
- e) Magnetic particle inspect nose gear casting assembly part number 145-34103 or -30 by qualified NDI personnel. Extra attention on cross piece trunnion attachment and collar at drag link attachment. (Ref. fig 5)

Fig. 5
Magnetic particle inspect for cracks and separation.

- f) If cracking or damage is noted contact Sierra Hotel Aero, Inc. for technical assistance. 651.306.1456
- g) Replace all non serviceable parts per Navion Parts Manual Chapter 24.

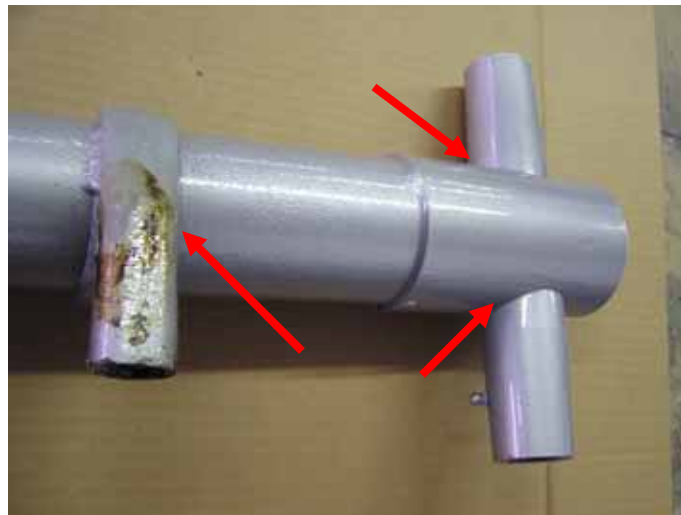
- e) Magnetic particle inspect main landing gear shock strut outer cylinder assembly part number 145-33903-1 or -101 and -2 or -102 by qualified NDI personnel. Extra attention on trunnion/ strut joint and collar and drag link attachment. (Ref fig 6, fig 7 and fig 8)

Fig. 6
Magnetic particle inspect for cracks and separation.

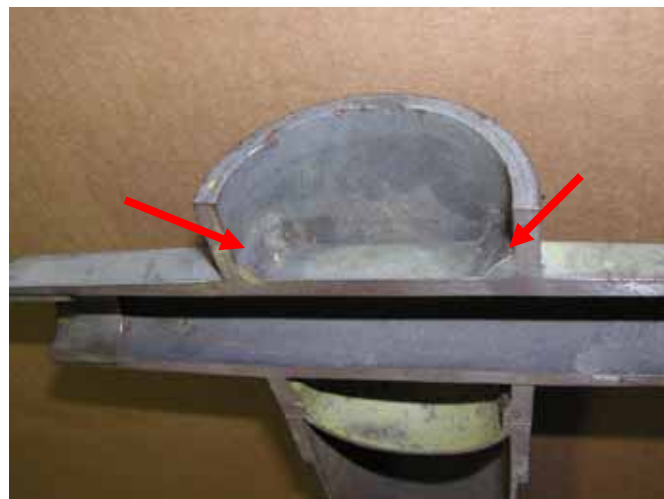
Fig. 7
Magnetic particle inspect for cracks and separation.

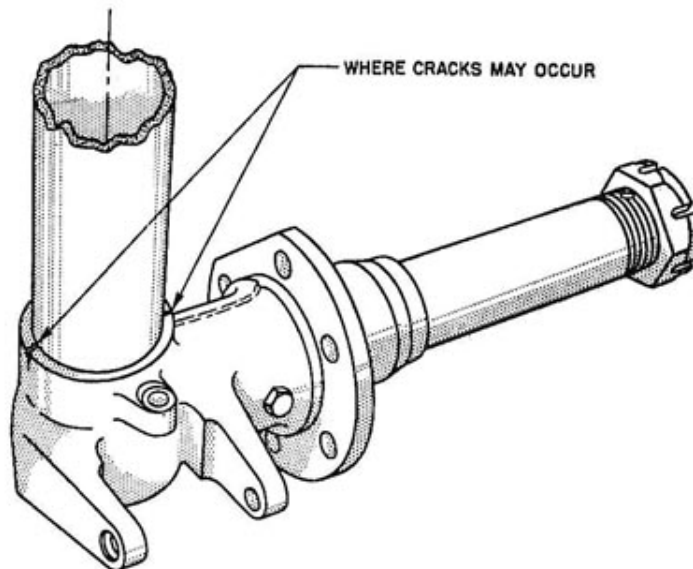
Fig. 9

- d) Florescent penetrant inspect main landing gear oleo axle attachment fitting part number 143-33113-9 and -10 by qualified NDI personnel. Extra attention on fitting/ oleo struts joint. (Ref fig 9)

Florescent penetrant inspect for cracks. If cracks are found,
contact Sierra Hotel Aero, Inc. (651.306.1456 or engineering@navion.com)
