# SERVICE LETTER

SERVICE LETTER NO. 78  
FEBRUARY 1, 1951

SUBJECT: FUEL SYSTEM ACCUMULATOR TANK MAINTENANCE AND MODIFICATION

SUBJECT	Fuel Accumulator Tank - Replacement
EFFECTIVITY	All Navions
DRAWING	Tanks experienced corroding Item # 2307 P/N 145-48004 Replacement tanks - Item # 2307-10 P/N 145-48006

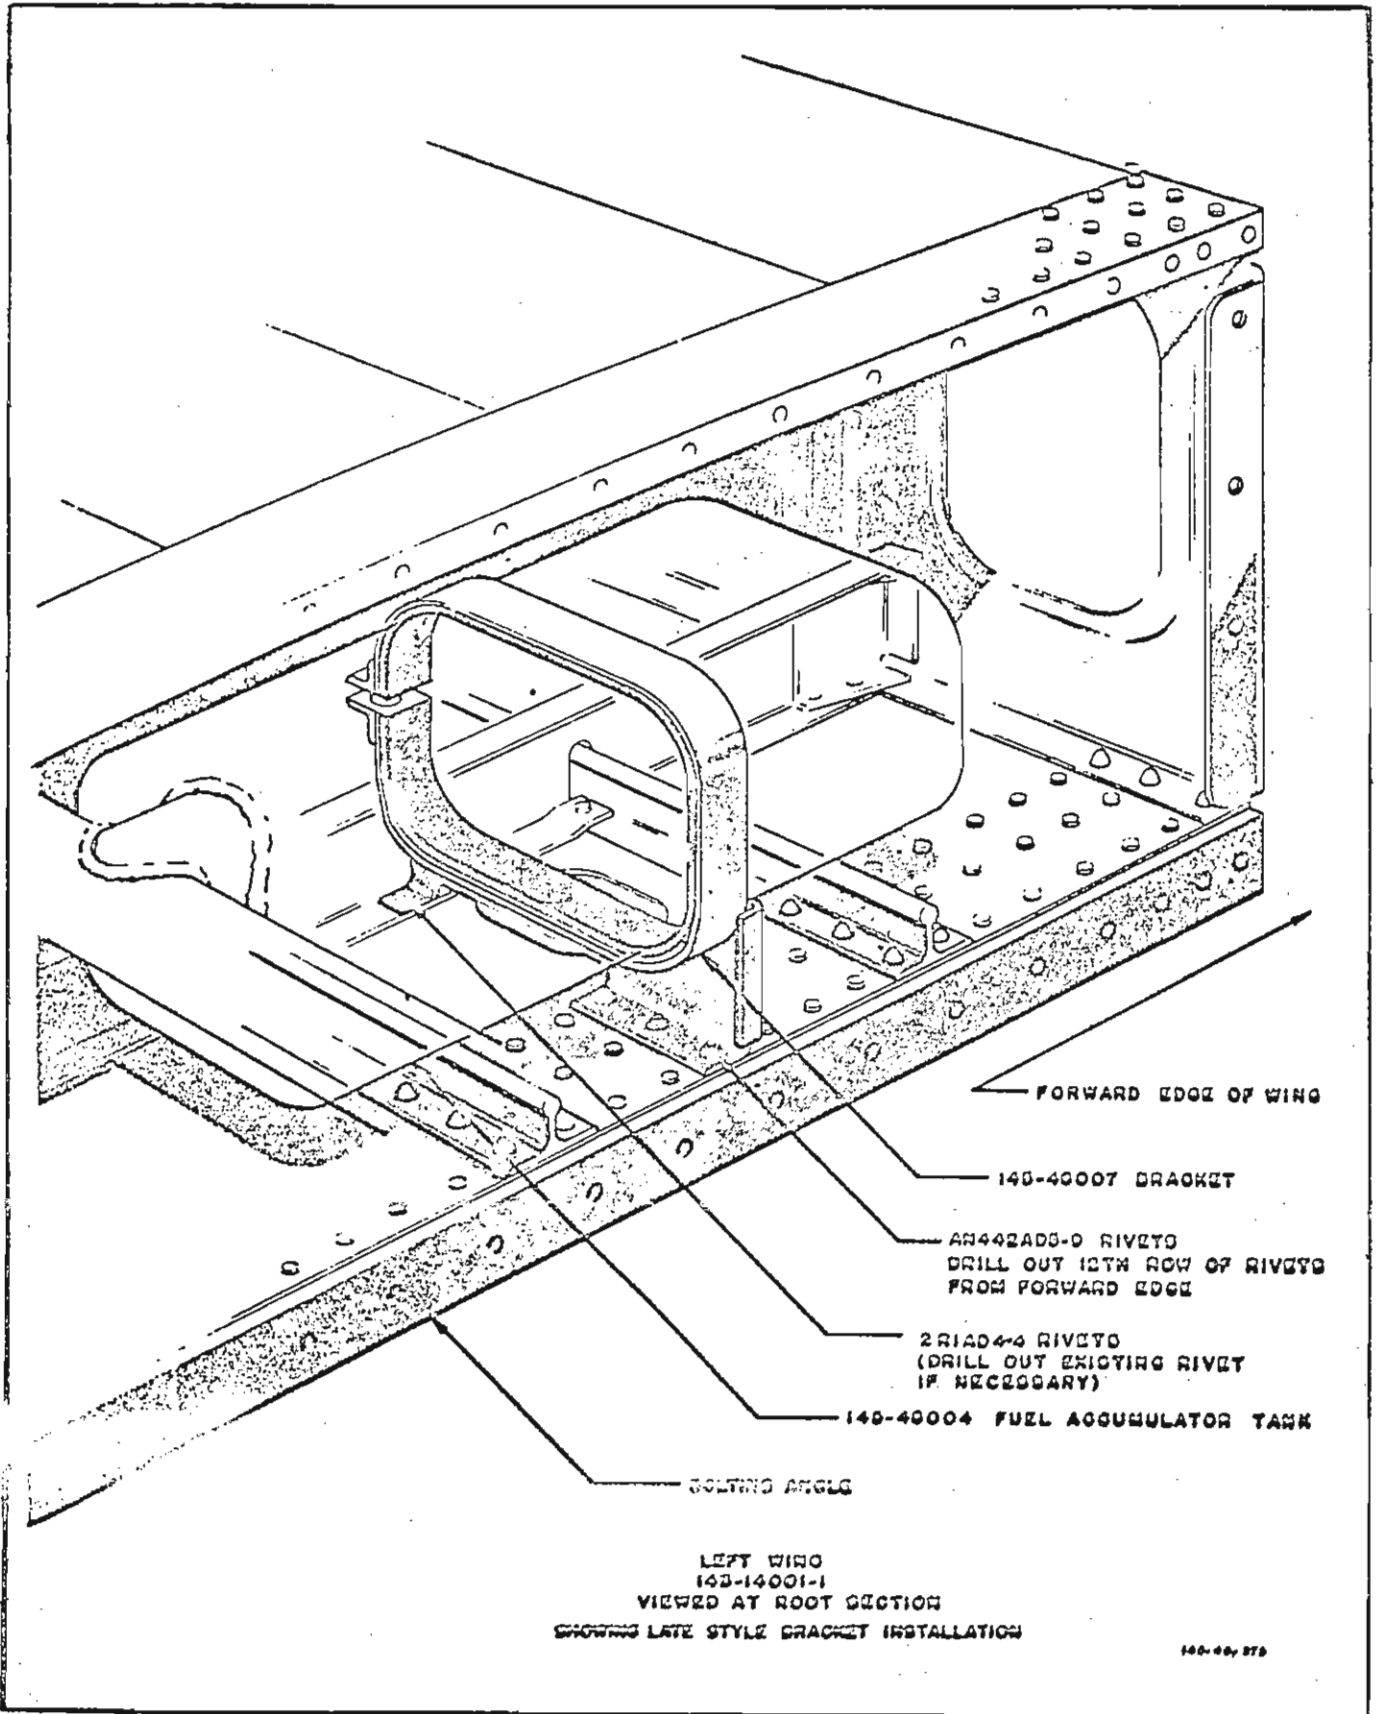
Figure 1 - Accumulator Tank Bracket

Navion airplanes prior to factory serial number NAV-4-1251 have the fuel accumulator tank supported by two 145-48008 brackets riveted to the 143-14010-20 center rib. Airplanes subsequent to NAV-4-1251 have the fuel accumulator tank supported by one 145-48007 bracket, riveted to the bolting angle of the left wing.

1. Inspect inside the root section to see if fuel accumulator tank bracket 145-48007 is installed. If the 145-48007 bracket is installed, remove it from the wing as follows:
  - a. Drill out the three AN442AD5-9 rivets which attach one end of 145-48007 bracket to the wing bolting angle. This is the 12th row of rivets aft of forward edge of the wing.

- b. Drill out one 2R1AD4-4 rivet attaching the outboard end of the 145-48007 bracket, and remove bracket from wing.
- c. Replace the first three removed rivets with AN442AD5-8 rivets. Replace the removed outboard rivet with one 2R1AD4-3 rivet.

1. Inspect the inside root section of left wing to see if the 145-48007 fuel accumulator tank bracket is installed. If bracket is not present, install the new 145-48007 bracket, received as a loose part, as follows:
  - a. Drill out three AN442AD5-8 rivets which run spanwise in the bolting angle. This is the 12th row of rivets aft of the forward edge of wing.
  - b. Clamp 145-48007 bracket in the wing with the flange of bracket over holes just drilled. Drill through bolting angle holes and bracket flange with a No. 21 (.159) drill.

CAUTION: Do not elongate holes in bolting angle.
  - c. Attach bracket to bolt angle with three AN442AD5-9 rivets.
  - d. Drill through rib, wing skin, and pilot hole on outboard flange of bracket with No. 30 (.128) drill, and install one 2R1AD4-4 rivet.
