NEW POLICY GOVERNS PUBLICATION OF OPERATING TIPS

ADJUSTMENT OF LANDING GEAR UP-LOCK CONTROL LINKAGE IMPORTANT

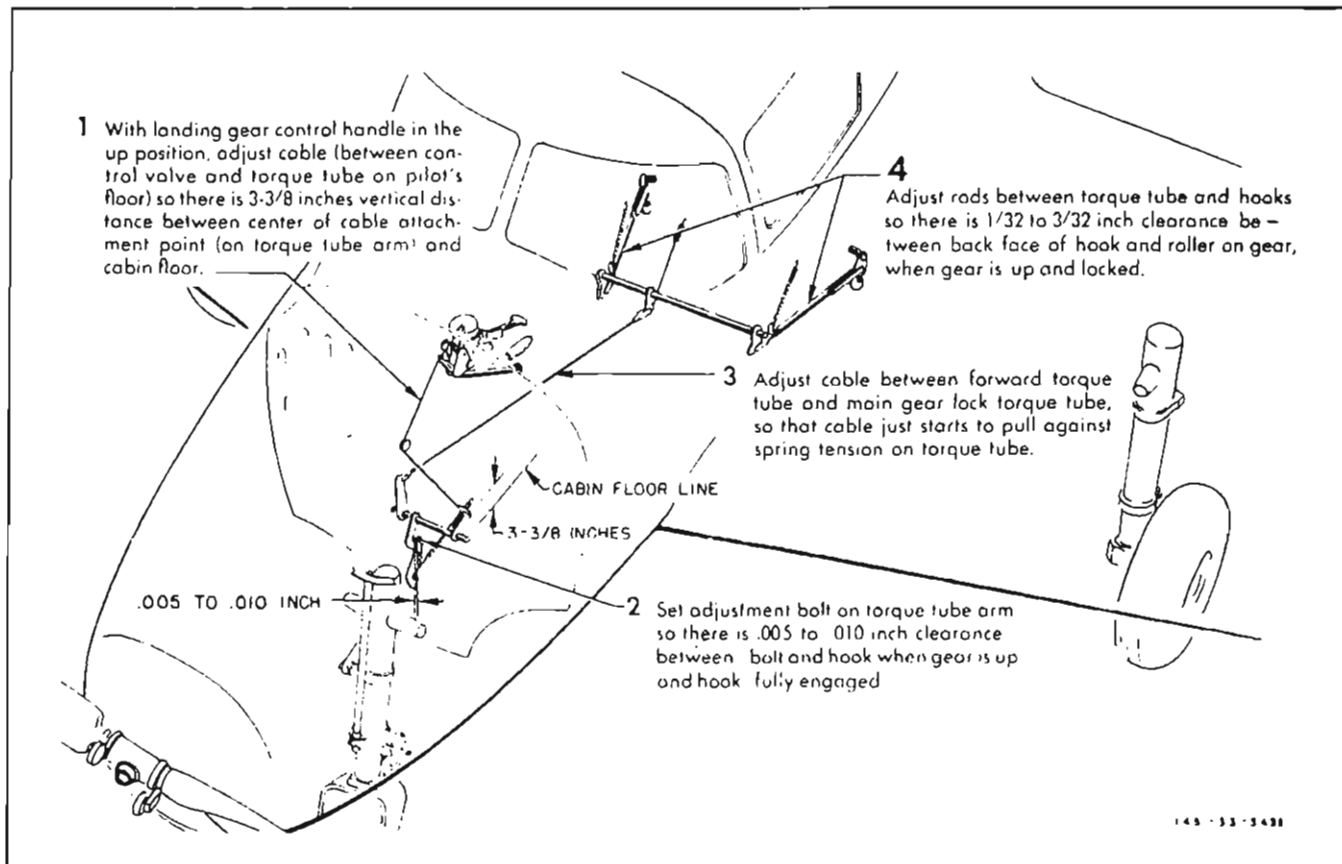
LANDING GEAR UP-LOCK AND CONTROL LINKAGE ADJUSTMENTS

A recent report of landing gear difficulty prompted us to write this article reminding all owners and pilots of the importance attached to correct adjustment of the control cable linkage for the landing gear up-locks. With the build-up of time on many of the Navions in service it is possible some extra cable length may exist in this linkage, in which case the up-lock hooks could be in a marginal position in respect to that required for best gear operation. The checking of this rigging is not a complicated operation and to make it even simpler we are reprinting below the uplock-control linkage diagram and rigging instructions in the Navion Service Manual. It is suggested you hand this issue of Operating Tips to your mechanic and ask him to check this control system so that you can be as-

sured of the best possible gear operation. Ask him to pay particular attention to the position of the hooks in relation to rollers on the bottom of the main gear struts and on the nose gear retract link during the gear up cycle. They should always be adjusted to set in such position as will eliminate any possibility of their getting jammed on the wrong side of the rollers. This is especially important in the case of the nose gear up-lock hook. After making the adjustments described below, it is recommended that the airplane be placed on jacks and the gear run up and down through several cycles with a mechanic observing operation of the hooks and their position in regard to the rollers as described above.

Should you as an owner and/or pilot ever encounter trouble with the landing gear on your Navion be sure to try the emergency gear lowering procedure with hydraulic power OFF, as well as ON, as described in all the later issues of the Operator Manual. Occasional practice of the emergency lowering procedure during

Remember: All gear operation, both normal and emergency, should be done only at air speeds of less than 100 mph IAS. The slower the better in the case of emergency operation.
